# FAILURE ANALYSIS OF SOME ORTHOPEDIC IMPLANTS

National Aeronautical Establishment

OTTAWA  
MAY 1980

MECHANICAL ENGINEERING  
REPORT  
MS-143

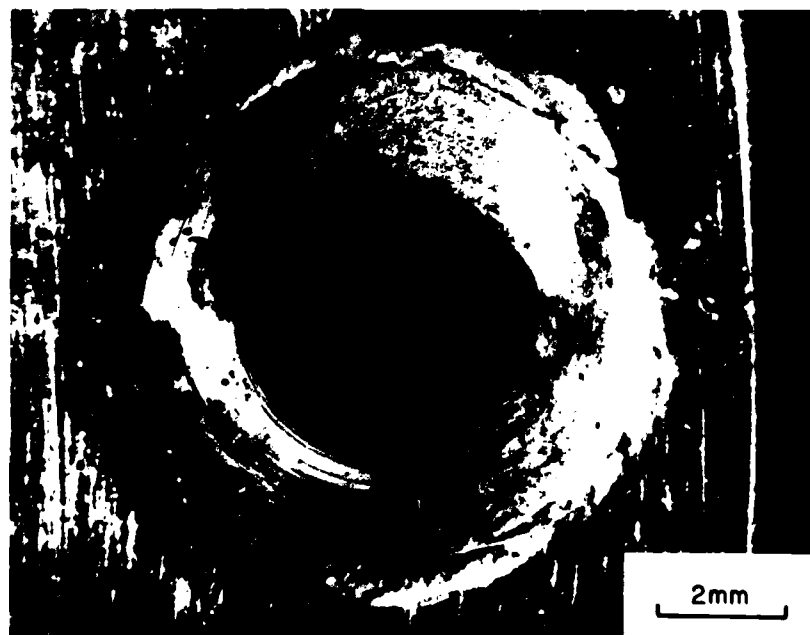
FIG. 2: CREVICE CORROSION AROUND A SCREW HOLE IN IMPLANT NUMBER 1

This implant, shown in Figure 1 was an Arbeitsgemeinschaft für Osteosynthesefragen (AO) plate, used to correct a subtrochanteric fracture of the femur. The part was removed because it fractured in service only 4 to 6 months after installation, and that period included 3 months spent in recovery, during which time the load factor was probably very low. The plate was about 18 cm long, and contained a  $95^\circ$  corner about 5 cm from one end. In the longer section there were 9 screw holes, seven of which were 4.6 mm diameter with a countersink, while the two holes nearest the corner were 6.5 mm diameter with a small countersink, probably to allow the screw to be inserted at various angles into the bone. However, this effectively reduced the cross sectional area of the plate by 44% and it was at the second hole from the corner where failure occurred. A contributing factor could have been a bend of  $9^\circ$  between the second and third screw holes, probably performed by the surgeon to contour the plate to the bone. Incidentally, cracking was also discovered at the third hole and heavy crevice corrosion was found at this and other screw holes, see Figure 2. At some screw holes, including the one at which the failure occurred, no evidence of corrosion was found.

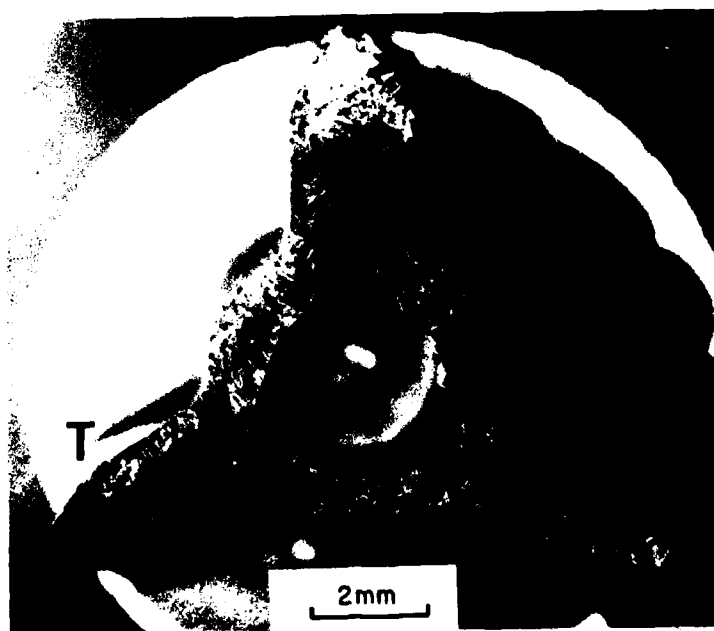
This implant was an adjustable Smith-Peterson (S-P) plate and nail, labelled 7A and 7B respectively in Figure 1. It was used in the treatment of an intertrochanteric fracture of the femur. No other information on the patient is available, but the device was removed after fracture of the splined nail. The fracture surface is shown in Figure 8. The nail had been bent, either during installation or during service, and the spline which was under tensile stress (labelled T in Fig. 8), when examined in the scanning electron microscope, revealed high cycle fatigue striations, Figure 9a. Slip band cracking, similar to that associated with stage 1 fatigue cracking in cast Co-Cr-Mo alloys (Ref. 10) was also seen, Figure 9b.

After fatigue crack initiation, bending overload probably caused the fracture mode to change to rapid crack propagation, resulting in a fibrous surface in which one could detect patterns relating to the orientation of the underlying dendritic structure. Finally the spline on the compressive side of the nail contained a shiny faceted cleavage-like fracture which may have resulted from an extremely high crack propagation rate.

FIG. 8: THE FRACTURE SURFACE OF IMPLANT NUMBER 7B

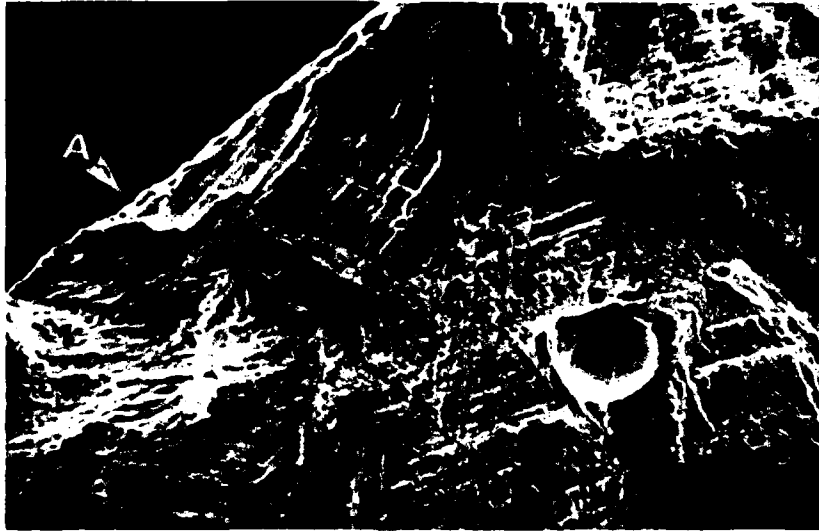
In the SEM, multiple crack initiation sites were observed, and one such example is shown at A in Figure 12. These sites were probably associated with porosity near the surface, and a large (18  $\mu$ m diameter) gas pore can be seen in the lower right-hand corner of Figure 12. The distribution of porosity can be better appreciated in a polished section shown in Figure 13.

**FIG. 12: SCANNING ELECTRON MICROGRAPH OF A TYPICAL  
CRACK INITIATION SITE IN IMPLANT NUMBER 8**

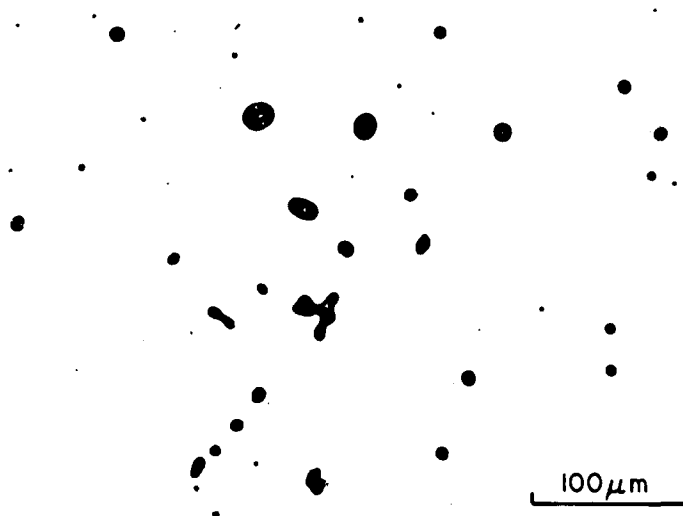
**FIG. 13: POROSITY IN A POLISHED SECTION  
OF IMPLANT NUMBER 8**

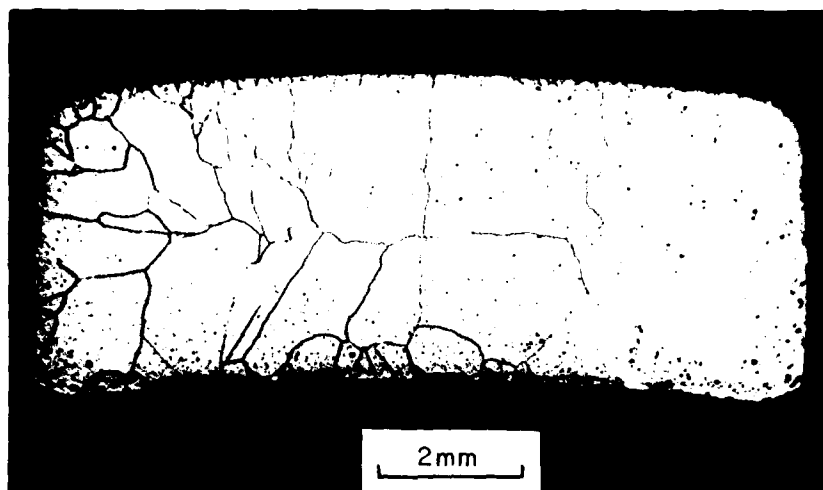
Metallography also revealed a very large grain size; the average grain diameter was estimated at about 1.0 mm. The grain size variation at low magnification is shown in Figure 14. Severe cases of interdendritic shrinkage cavities were also noted.

**FIG. 14: GRAIN SIZE VARIATIONS IN A SECTION  
OF IMPLANT NUMBER 8**

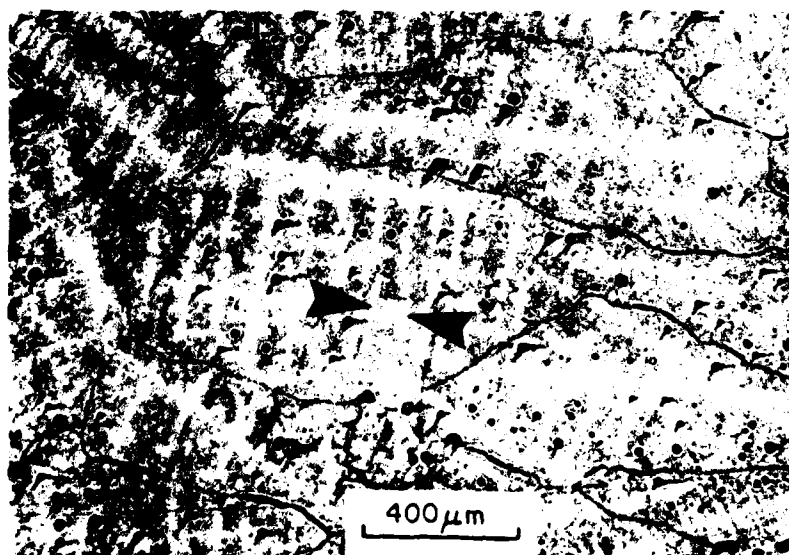
**FIG. 15: SECTION THROUGH A SLOWLY COOLED Co-Cr-Mo ALLOY  
CASTING AFTER HEAT TREATMENT  
THE ORIGINAL SECONDARY DENDRITE ARM SPACING IS SHOWN  
BETWEEN ARROW HEADS**

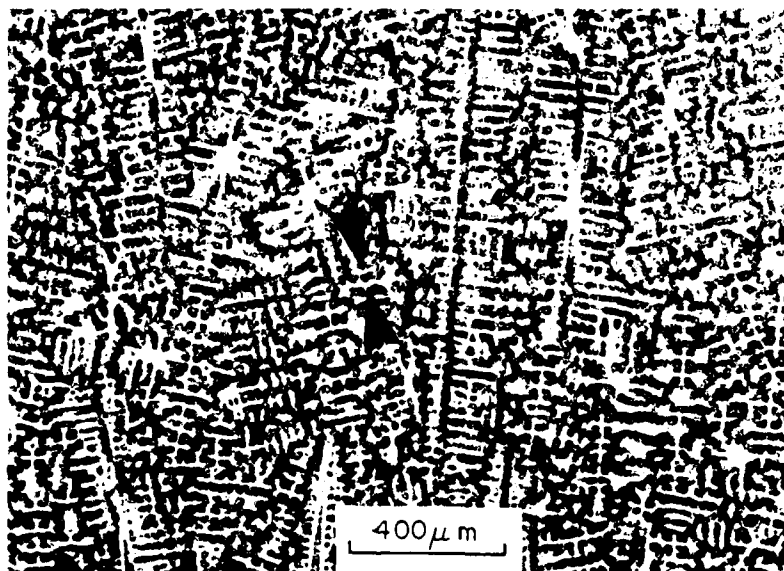
FIG. 16: THE SAME ALLOY AS SHOWN IN FIGURE 15  
BUT COOLED AT A FASTER RATE  
NOTE THE DECREASED SECONDARY DENDRITE ARM SPACING  
AND THE REDUCED LEVEL OF POROSITY
